Aviation Investigation Preliminary Report

Location:	Owenton, KY	Accident Number:	ERA25FA005
Date & Time:	October 7, 2024, 17:35 Local	Registration:	N230AE
Aircraft:	Bell 206L-3	Injuries:	3 Fatal
Flight Conducted Under:	Part 135: Air taxi & commuter - Non-scheduled - Air Medical (Medical emergency)

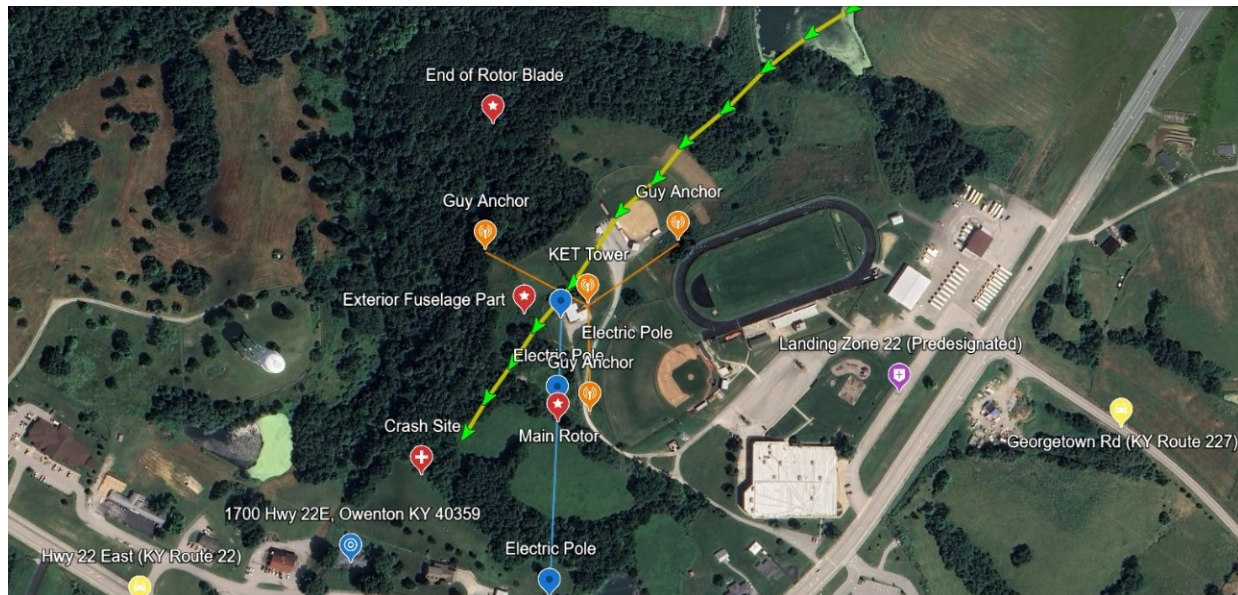
ADS-B track data revealed that the helicopter approached the tower from the northeast on an approximate ground track of 210° magnetic at an altitude of about 1,300 ft msl. At the time,

the sun was 18° above the horizon on an azimuth of 246°. Figure 1 shows the area of the accident site including the helicopter's ADS-B ground track, the guyed tower, and the LZ.

Figure 1 - Aerial image with the helicopter's ground track, as well as positions of the accident site, select pieces of wreckage, the tower and guy anchors, and the LZ annotated.

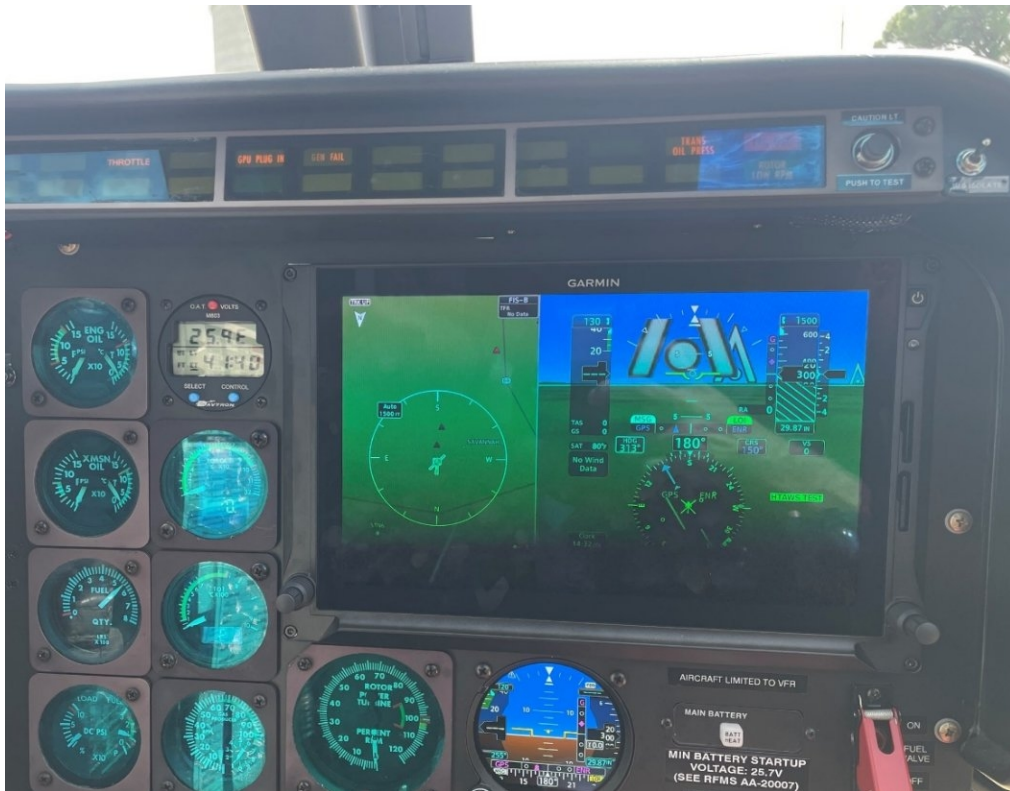
The helicopter was equipped with a two-axis autopilot, a Garmin 650 GPS, a Garmin 500txi cockpit display, synthetic vision, and a Helicopter Terrain Awareness and Warning System (HTAWS). These systems provided both visual and aural terrain and obstacle advisories to the pilot and crew. Figure 2 shows an exemplar instrument panel including terrain and obstacle awareness displays.

Figure 2 - Exemplar of instrument panel as configured in accident helicopter.
